## 2K7 BIOCIDES ADDRESSES PREMATURE COILED TUBING FAILURES IN THE MONTNEY FORMATION

Comprehensive post-failure analysis identifies microbiologically influenced corrosion

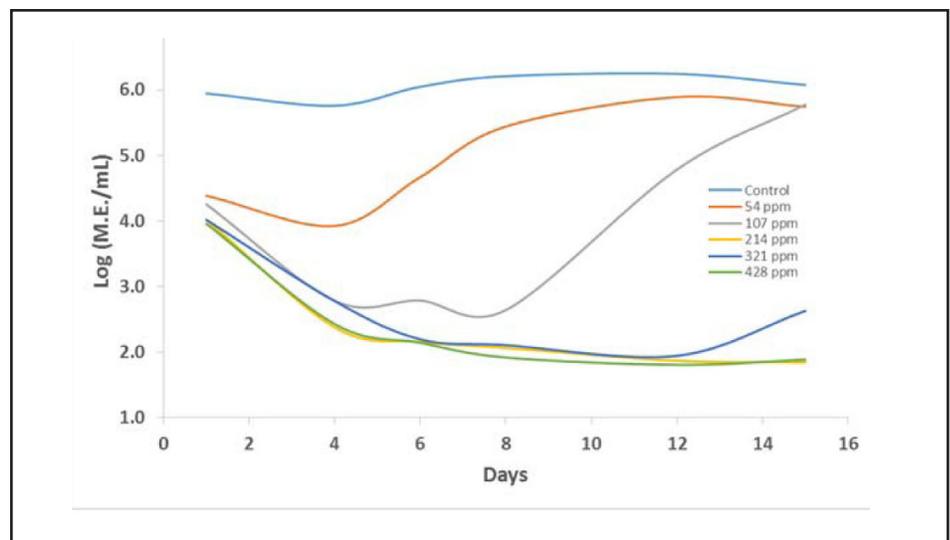
Fig. 1—Loading evaluation of 2K7 biocide.

The 2K7 biocide was effective at 100 ppm for 8 days – twice as long as the DBNPA at the same concentration – and at >200 ppm reduced bacterial levels for 2 weeks (Fig. 1). 2K7 biocide works by disrupting the activity of bacterial membrane proteins causing cellular collapse. Unlike other biocides, which can react with friction reducers negating the effect of both, 2K7 is nonionic and does not react with other fluid additives.
